**Flood Control Project Maintenance  
Levee Inspections**  
**LMA District Cover Sheet**  
**Spring 2017 Levee Inspection Results**

**Reclamation District No. 0010 Honcut**

**Spring 2017 Levee Inspection Results**

Waterway			Bank	Unit Miles
Unit No. 01 Simmerly Slough			Right	7.65
	Spring (March - May)	Summer (June - August)	(September - November) Fall	Winter (December - February)
Unit Maintenance Rating (Fall Only)				
Date of Inspection	4/11/2017 - 4/11/2017			
DWR Inspector	Sterling York			
Accompanied By	Finlay Williams

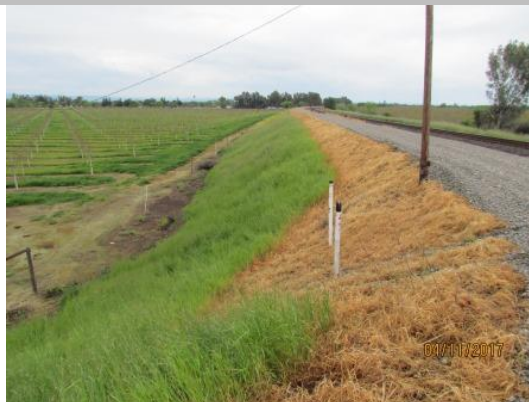
Photo 1 of 1 : SP\_2017\_RD0010\_163\_29\_20170425\_00093.jpg

LM Start	0.00	Rating **	M	Issue No.	29
LM End	1.62	Issue Type +	Ma	Location *	LS
Category	Earthen Levee			GPS Latitude/Longitude	
				Start	End
Item	Vegetation			39.163718 °	39.169305 °
				-121.609935 °	-121.585804 °
DWR ID	DWR_RD0010_01_s_2017_29				
Comment Code					
V1 : Control annual grass and weeds on the levee slopes and easements.					
Inspector Comment					
Annual grass need to be maintained, the shoulder and partial top of slope has been sprayed, Spring 2017.

View looking upstream of the annual grass that need to be maintained, the shoulder and partial top of slope has been sprayed. Spring 2017.

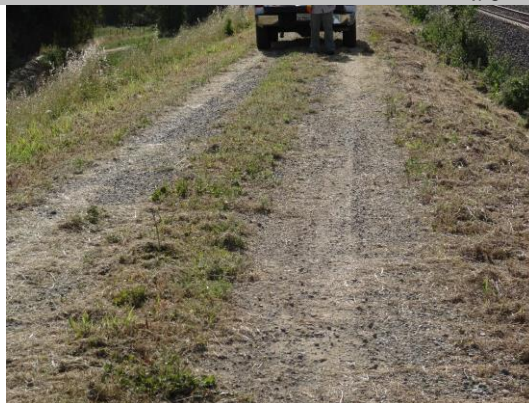
Photo 2 of 3 : UCIP\_SP\_2017\_24806\_44541.jpg

FS\_ID:24806  
DS\_ID:21257  
EP\_NO: 13015  
Repair Type: Non-Urgent  
Crossing Status: Found  
UCIP Comments: New gravel indicates work was recently completed. Will need to contact owner to obtain information pertaining to work completed. Need to contact owner to determine if crossing is still active and to determine last inspection date. Will need copy of letter showing crossings passed inspection. This crossing is referenced in the USACE Periodic Inspection as item USACE\_CESPK\_HON1\_2013\_p\_0075.  
FIELD\_STRUCT\_DESC: 4-inch pipe sleeved through an 8-inch pipe through the levee, 30.0 feet below the crown. Annular spaced grouted. Cutoff walls on both ends within the levee. (Permit No. 13015-1981)  
FS Date: 4/29/2013

View of levee crown looking downstream.

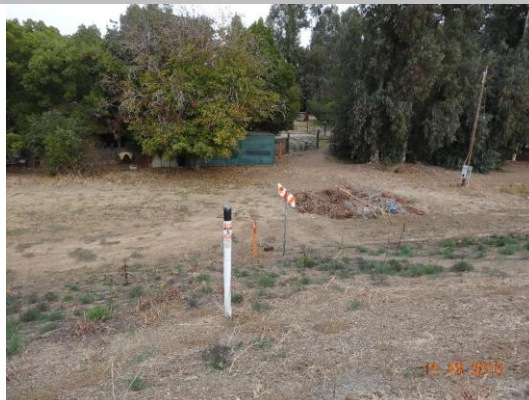
Photo 3 of 3 : UCIP\_SP\_2017\_24806\_44543.jpg

View of landward side--gas marker and conduit line marker.

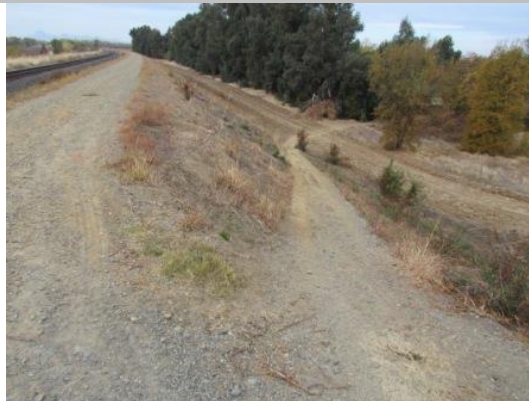
Photo 1 of 2 : SP\_2017\_RD0010\_163\_48\_20170316\_00017.jpg

LM Start	0.72	Rating **	M	Issue No.	48
LM End	0.72	Issue Type +	Ma	Location *	LS
Category	Earthen Levee			GPS Latitude/Longitude	
				Start	End
Item	Slope Stability			39.161198°	39.161198°
				-121.597102°	-121.597102°
DWR ID	DWR_RD0010_01_f_2013_48				
Comment Code					
S3 : Repair the levee slope damaged by vehicle traffic and prevent access where possible.					
Inspector Comment					
Ramp is caused by constant ATV use on levee slope. Fall 2016.

This photo was taken from the crown looking down the landward slope at an ATV access road that has been formed over time to provide access to the waterward side. Fall 2013.

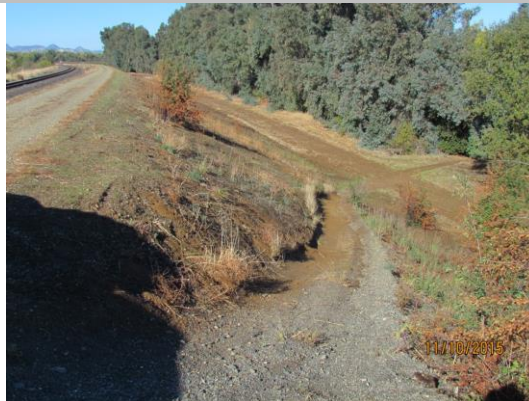
Photo 2 of 2 : SP\_2017\_RD0010\_163\_48\_20170316\_00018.jpg

View of the slope stability on the landward side of the levee looking downstream. Fall 2015.

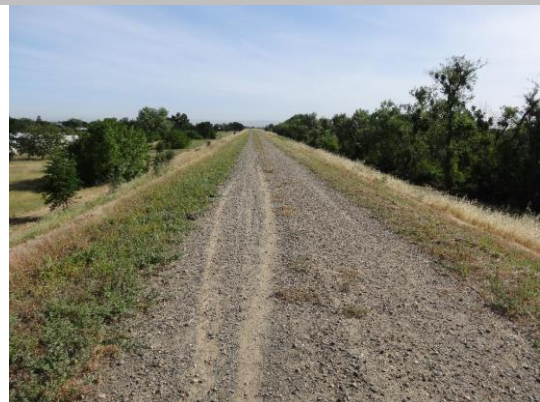
Photo 2 of 3 : UCIP\_SP\_2017\_50058\_51410.jpg

View of levee crown looking downstream.

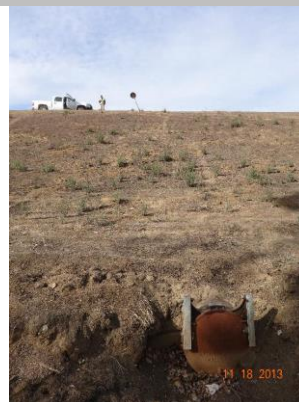
Photo 2 of 3 : UCIP\_SP\_2017\_27748\_51450.jpg

View of slope located on waterward side.

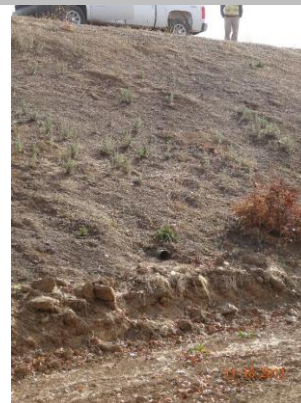
Photo 1 of 1 : UCIP\_SP\_2017\_40545\_51418.jpg

Comment Code					
Inspector Comment					
FS_ID:40545 DS_ID:21260 EP_NO: 4555 Repair Type: Non-Urgent Crossing Status: Indicator Found UCIP Comments: Pipe is approximately 4-6 inches in diameter located near the toe of levee. Crossing is approximately 50 feet downstream of 24-inch pipe. Need to contact owner to determine status of this crossing and to verify the purpose of crossing. If crossing is no longer in use owner will need to contact the CVFPB to comply with Title 23. FIELD_STRUCT_DESC: Abandoned 6-inch steel drainpipe through the levee, 1.0 feet below the crown. Siphon breaker on the waterward shoulder. Pump located at landward toe. Revetment around discharge end of pipe, draining into ditch at waterward toe. Pipe is not buried on berms, gravel pad over pipe across levee crown for vehicular access. Pipe retained through levee under Permit No. 4555 (1964). FS Date: 4/29/2013

Pipe through levee near waterward toe.

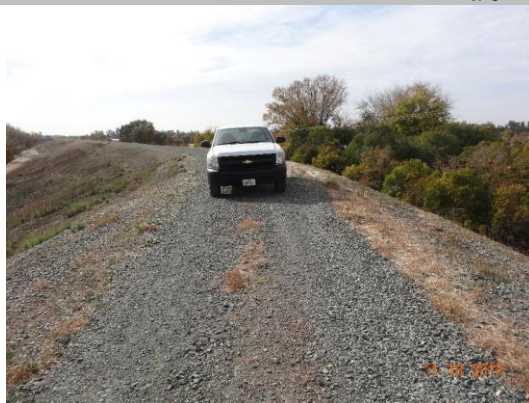
Photo 1 of 3 : UCIP\_SP\_2017\_27725\_51386.jpg

FS\_ID:27725  
DS\_ID:21262  
EP\_NO: N/A  
Repair Type: Non-Urgent  
Crossing Status: Found  
UCIP Comments: Crossing appears not to be in use--need to contact owner. Need to coordinate with owner to determine status of crossing. If crossing is no longer in use owner will need to contact the CVFPB to comply with Title 23. This crossing is referenced in the USACE Periodic Inspection as item USACE\_CESPK\_HON1\_2013\_p\_0012.  
FIELD\_STRUCT\_DESC: 10-inch steel pipe through the levee, 7.3 feet below the crown. Siphon breaker in CM riser on the waterward slope. Pump on the waterward berm-pump not present. Switch house on the waterward slope-no switch house present. 24-inch concrete standpipe at the landward toe. (USACE-1955). This entry matches the Drainage or Irrigation Structure referenced in O&M manual (Station 14+82). Concrete pad is still present on waterward side.  
FS Date: 4/29/2013

View of levee crown looking upstream.

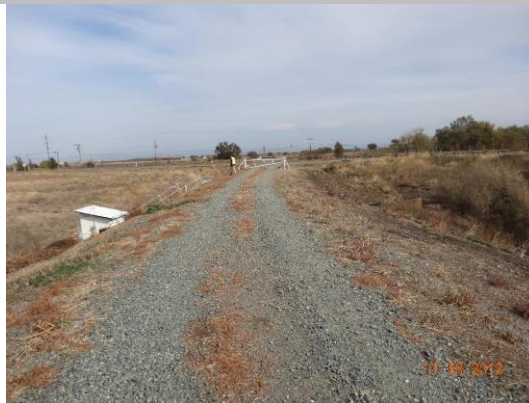
Photo 2 of 3 : UCIP\_SP\_2017\_27725\_51387.jpg

View of levee crown looking downstream.

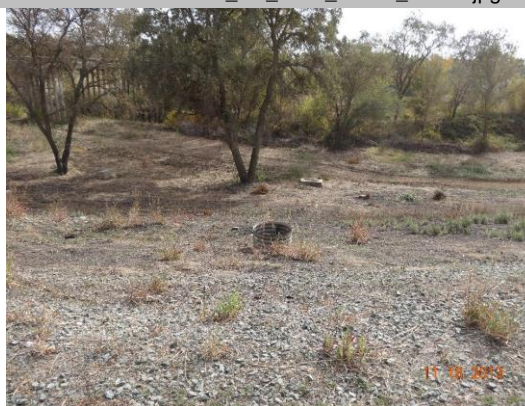
Photo 3 of 3 : UCIP\_SP\_2017\_27725\_51384.jpg

Comment Code					
Inspector Comment					
FS_ID:27725 DS_ID:21262 EP_NO: N/A Repair Type: Non-Urgent Crossing Status: Found UCIP Comments: Crossing appears not to be in use--need to contact owner. Need to coordinate with owner to determine status of crossing. If crossing is no longer in use owner will need to contact the CVFPB to comply with Title 23. This crossing is referenced in the USACE Periodic Inspection as item USACE_CESPK_HON1_2013_p_0012. FIELD_STRUCT_DESC: 10-inch steel pipe through the levee, 7.3 feet below the crown. Siphon breaker in CM riser on the waterward slope. Pump on the waterward berm-pump not present. Switch house on the waterward slope-no switch house present. 24-inch concrete standpipe at the landward toe. (USACE-1955). This entry matches the Drainage or Irrigation Structure referenced in O&M manual (Station 14+82). Concrete pad is still present on waterward side. FS Date: 4/29/2013

View of waterward side-slopes cleared.

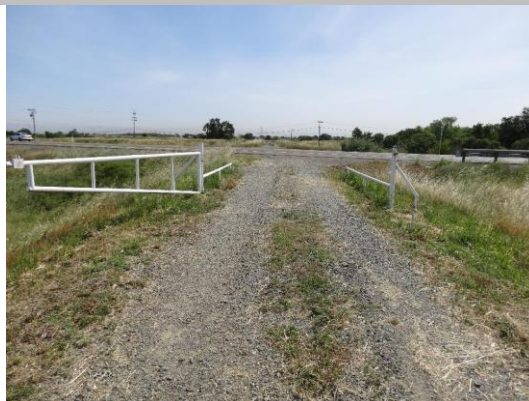
Photo 2 of 3 : UCIP\_SP\_2017\_24811\_44581.jpg

View of levee crown looking downstream--access gate near HWY 70.

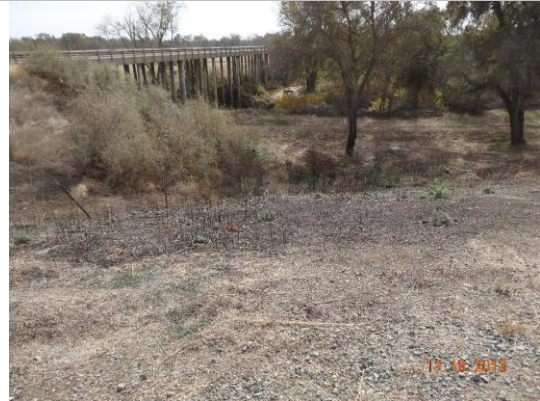
Photo 3 of 3 : UCIP\_SP\_2017\_24811\_44585.jpg

Item	DWR UCIP LMA Responsibility			39.168717 °	39.168717 °	
				-121.590570 °	-121.590570 °	
DWR ID						
Comment Code						
Inspector Comment						
FS_ID:24811						
DS_ID:21264						
EP_NO: N/A						
Repair Type: No Action Needed						
Crossing Status: Found						
UCIP Comments: This crossing is referenced in the USACE Periodic Inspection as item USACE_CESPK_HON1_2013_p_0004.						
FIELD_STRUCT_DESC: [R.D. No 10 Drainage Plant] 16-inch steel pipe through the levee, 7.0 feet below the crown. Steel cutoff plate around pipe at center of levee. Siphon breaker on the landward slope. Flap gate on the waterward end. Pump in pit at landward toe, with steps along the landward slope. Saddle and splash apron (8-foot) at the discharge end of the pipe. Concrete headwall at landward toe. Metal shed on landward slope. (USACE-1955). This entry matches the Drainage or Irrigation Structure referenced in O&M manual (Station 13+88).

View of waterward side.

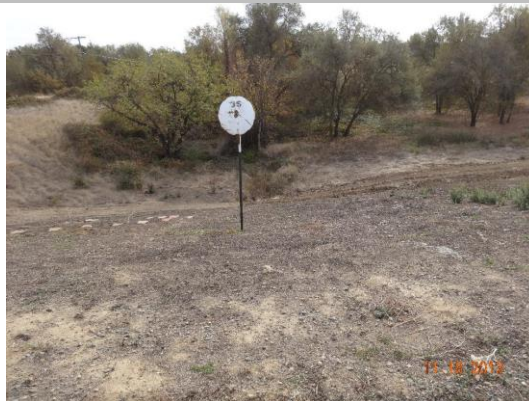
Photo 1 of 3 : UCIP\_SP\_2017\_49986\_44588.jpg

FS\_ID:49986  
DS\_ID:21318  
EP\_NO: N/A  
Repair Type: Urgent  
Crossing Status: Found  
UCIP Comments: 7/01/2016 Pipe wall in poor condition--deteriorated pipe wall indicated by holes at the inlet and outlet pipe collar. Recommend internal integrity inspection of the pipe through the levee to determine extent of damage. (DWR UCIP - omagana)4/29/2013 Holes present on pipe wall. Need to contact owner to notify of issue with pipe. Also need to contact DWR Inspector and CVFPB to determine how to address issue. This crossing is referenced in the USACE Periodic Inspection as item USACE\_CESPK\_HON1\_2013\_p\_0140. Pipe should be 30-inch instead of 36-inch mentioned Periodic Inspection. (DWR UCIP - omagana)  
FIELD\_STRUCT\_DESC: 30-inch corrugated metal drainage pipe through the levee, approximately 30 feet below the crown. Two CM cutoff walls around the pipe on both sides. Saddle and splash apron are located on the waterside (WS) discharge point. Concrete headwall and sluice gate are located on the landside (LS). [Additional Reference(s): DWR Levee Log, 2005. USACE Sacramento O&M Manual Unit No. 151, May 1953, Station 10+38].

View of WS--marker present on WS shoulder.

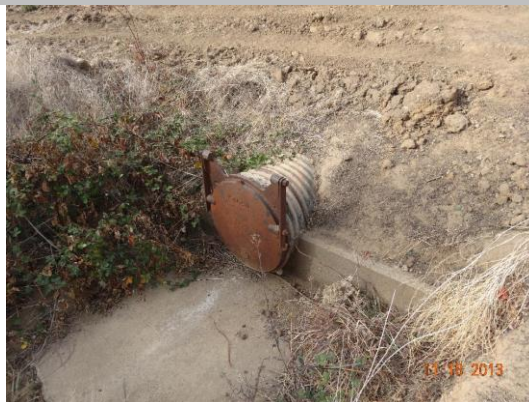
Photo 2 of 3 : UCIP\_SP\_2017\_49986\_44587.jpg

View of headwall, pipe, and flap gate located on WS.

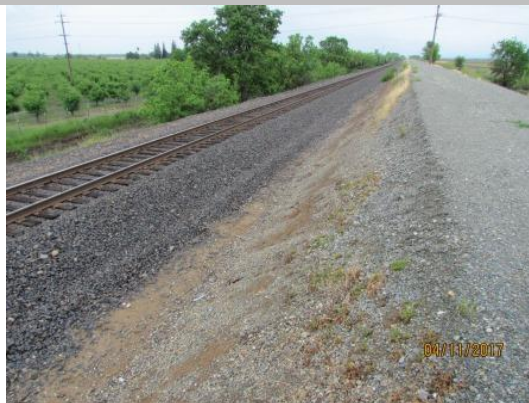
Photo 1 of 1 : SP\_2017\_RD0010\_163\_35\_20170425\_00097.jpg

LM Start	1.62	Rating **	A	Issue No.	35
LM End	7.65	Issue Type +	Ma	Location *	LS
Category	Earthen Levee			GPS Latitude/Longitude	
				Start	End
Item	Vegetation			39.169306 °	39.256220 °
				-121.585804 °	-121.574897 °
DWR ID	DWR_RD0010_01_s_2017_35				
Comment Code					
V1 : Control annual grass and weeds on the levee slopes and easements.					
Inspector Comment					
Well maintained annual grasses, Spring 2017.

View of well maintained annual grasses on the landside, Spring 2017.

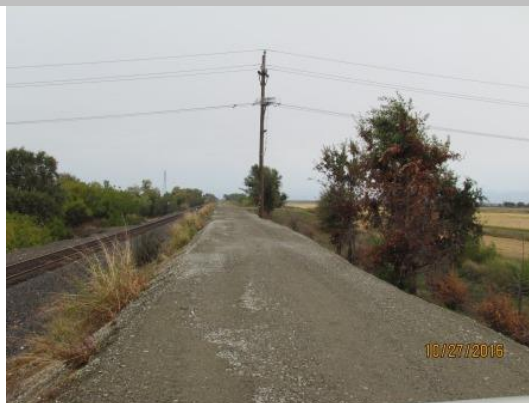
Photo 1 of 1 : SP\_2017\_RD0010\_163\_66\_20170316\_00033.jpg

LM Start	1.64	Rating **	M	Issue No.	66
LM End	1.64	Issue Type +	Ma	Location *	WS
Category	Earthen Levee			GPS Latitude/Longitude	
				Start	End
Item	Trim / Thin Trees			39.169721 °	39.169721 °
				-121.585759 °	-121.585759 °
DWR ID	DWR_RD0010_01_s_2016_66				
Comment Code					
T1 : Trim trees to at least five feet above ground level.					
Inspector Comment					
Small trees should be trimmed up for visibility and access. Fall 2016.

View of a small tree that needs to be trimmed for visibility and access on the land side slope looking upstream. Fall 2016.

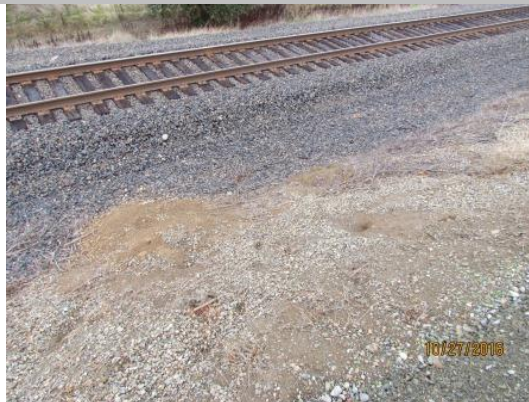
Photo 1 of 1 : SP\_2017\_RD0010\_163\_65\_20170316\_00032.jpg

LM Start	1.75	Rating **	M	Issue No.	65
LM End	1.75	Issue Type +	Ma	Location *	LS
Category	Earthen Levee			GPS Latitude/Longitude	
				Start	End
Item	Animal Control			39.171200 °	39.171200 °
				-121.585576 °	-121.585576 °
DWR ID	DWR_RD0010_01_s_2016_65				
Comment Code					
A3 : No rodents visible, but rodent burrows visible; need to backfill and compact or grout burrows.					
Inspector Comment					
Squirrel hole still are visible but no sign of activity, Fall 2016.

View of squirrel holes on the landside, no rodent activity was observed. Fall 2016.

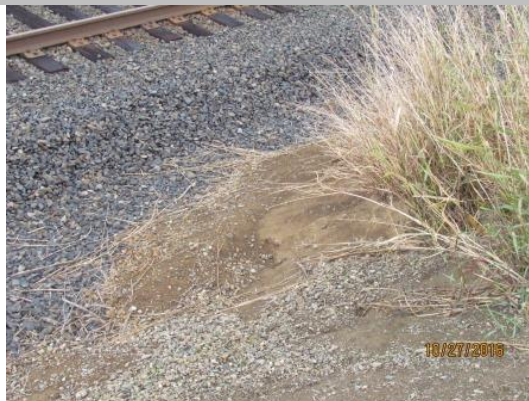
Photo 1 of 1 : SP\_2017\_RD0010\_163\_64\_20170316\_00031.jpg

LM Start	1.81	Rating **	M	Issue No.	64
LM End	1.81	Issue Type +	Ma	Location *	LS
Category	Earthen Levee			GPS Latitude/Longitude	
				Start	End
Item	Animal Control			39.172094 °	39.172094 °
				-121.585472 °	-121.585472 °
DWR ID	DWR_RD0010_01_s_2016_64				
Comment Code					
A3 : No rodents visible, but rodent burrows visible; need to backfill and compact or grout burrows.					
Inspector Comment					
Squirrel hole still are visible but no sign of activity, Fall 2016.

View of squirrel holes on the landside, no rodent activity was observed. Fall 2016.

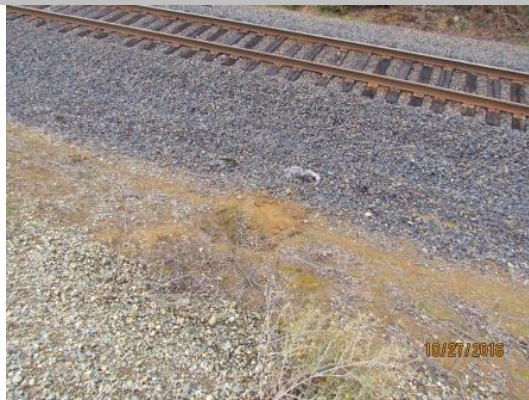
Photo 1 of 1 : SP\_2017\_RD0010\_163\_63\_20170316\_00030.jpg

LM Start	2.09	Rating **	M	Issue No.	63
LM End	2.09	Issue Type +	Ma	Location *	LS
Category	Earthen Levee			GPS Latitude/Longitude	
				Start	End
Item	Animal Control			39.176153 °	39.176153 °
				-121.584958 °	-121.584958 °
DWR ID	DWR_RD0010_01_s_2016_63				
Comment Code					
A3 : No rodents visible, but rodent burrows visible; need to backfill and compact or grout burrows.					
Inspector Comment					
Squirrel hole still are visible but no sign of activity, Fall 2016.

View of squirrel holes on the landside, no rodent activity was observed. Fall 2016.

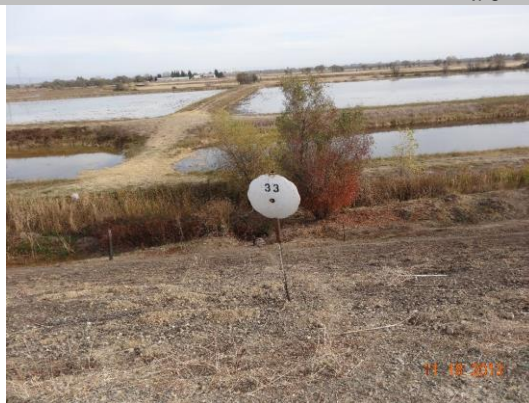
Photo 1 of 3 : UCIP\_SP\_2017\_27745\_51429.jpg

View of waterward side--marker indicating crossing visible on waterward shoulder.

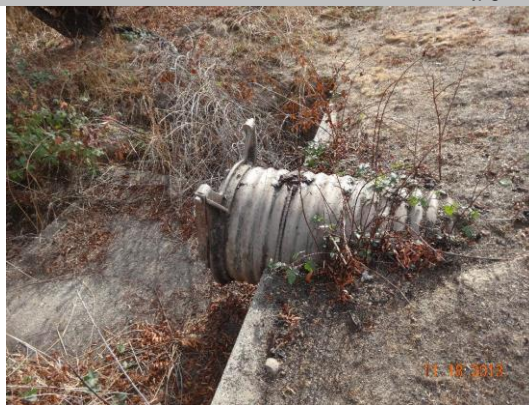
Photo 2 of 3 : UCIP\_SP\_2017\_27745\_51432.jpg

View of pipe, headwall, and flap gate located on waterward side.

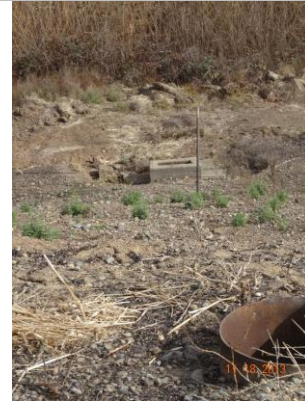
Photo 1 of 3 : UCIP\_SP\_2017\_49987\_44608.jpg

Comment Code					
Inspector Comment					
FS_ID:49987 DS_ID:21272 EP_NO: 14020 Repair Type: Urgent Crossing Status: Indicator Found UCIP Comments: 7/01/2016 Dense vegetation--unable to determine if the sink hole/slope depression noted back in Jan 2013 in the USACE's PI Report is still present. Need to revisit the site once vegetation from the slopes has been cleared. (DWR UCIP - omagana)4/29/2013 Unable to determine status of crossing--sink hole was observed as part of the USACE Periodic Inspection Report dated May 2013. Need to coordinate with owner to determine status of crossing. If crossing is no longer in use owner will need to contact the CVFPB to comply with Title 23. Need to confirm with Finney to determine if pump and controls belong to pipe crossing located on landward side. This crossing is referenced in the USACE Periodic Inspection as item USACE_CESPK_HON1_2013_p_0192. (DWR UCIP - omagana) FIELD_STRUCT_DESC: 10-inch steel drainage pipe sleeved through a 16-inch steel pipe, 5 feet below the crown. Annular gap between 10-inch and 16-inch pipes has been grouted. Concrete cutoff wall around pipe is located at the center of levee. Siphon breaker is located on the waterside (WS) shoulder. Flap gate and concrete headwall are located on the WS toe. Pump is located on the landside (LS). This drainage pipe is used to divert water from the drainage ponds, that serves the residential development located on the LS, to the Jack Slough. (Permit No. 14020, 1986 - California North Lands, Inc.) [Additional Reference(s): DWR Levee Log, 2005]. FS Date: 7/1/2016

View of WS--concrete box located located at WS toe.

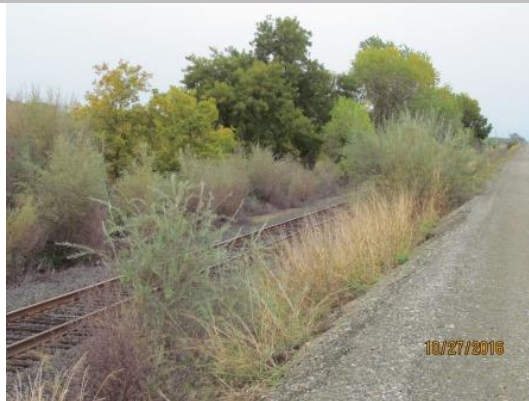
Photo 1 of 1 : SP\_2017\_RD0010\_163\_55\_20170316\_00024.jpg

LM Start	3.01	Rating **	M	Issue No.	55
LM End	3.01	Issue Type +	Ma	Location *	LS
Category	Earthen Levee			GPS Latitude/Longitude	
				Start	End
Item	Trim / Thin Trees			39.189497 °	39.189497 °
				-121.583308 °	-121.583308 °
DWR ID	DWR_RD0010_01_s_2016_55				
Comment Code					
T3 : Trim and thin trees to allow visibility of the ground and room to flood fight.					
Inspector Comment					
Small willow tree on landside slope should be removed. Fall 2016.

View of small willow trees on the landside slope looking upstream. Fall 2016.

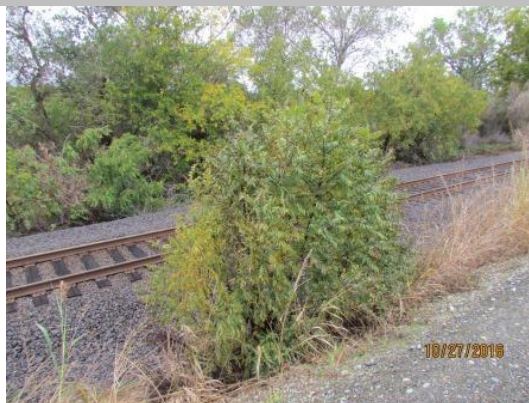
Photo 1 of 1 : SP\_2017\_RD0010\_163\_54\_20170316\_00023.jpg

LM Start	3.17	Rating **	M	Issue No.	54
LM End	3.17	Issue Type +	Ma	Location *	LS
Category	Earthen Levee			GPS Latitude/Longitude	
				Start	End
Item	Trim / Thin Trees			39.191796 °	39.191796 °
				-121.583024 °	-121.583024 °
DWR ID	DWR_RD0010_01_s_2016_54				
Comment Code					
T3 : Trim and thin trees to allow visibility of the ground and room to flood fight.					
Inspector Comment					
Small willow tree on landside toe should be removed. Fall 2016.

View of small willow trees on the landside toe looking upstream. Fall 2016.

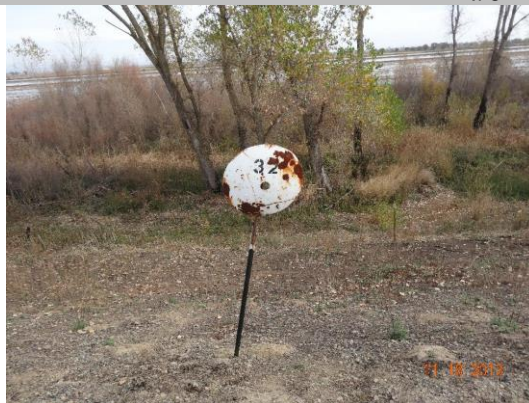
Photo 1 of 3 : UCIP\_SP\_2017\_24816\_44611.jpg

FS\_ID:24816  
DS\_ID:21317  
EP\_NO: N/A  
Repair Type: Non-Urgent  
Crossing Status: Indicator Found  
UCIP Comments: Indicator marker visible on WS; Dense vegetation on waterward toe and landward side access limits the inspector's visibility to identify signs of pipe failure (leaks) along the slope. Recommend removing vegetation along pipe alignment to conduct proper inspection of structure and appurtenances. Access to landward side will need to be coordinated with railroad. Need to coordinate with owner to determine status of crossing. If crossing is no longer in use owner will need to contact the CVFPB to comply with Title 23. This crossing is referenced in the USACE Periodic Inspection as item USACE\_CESPK\_HON1\_2013\_p\_0204.  
FIELD\_STRUCT\_DESC: 24-inch CM drainpipe through the levee, 23.0 feet below the crown. Flap gate on waterward end. Concrete headwall at both toes. Siphon breaker on waterward shoulder-unable to find. Concrete saddle and apron on waterward side. (USACE-1953). This entry matches the Drainage or Irrigation Structure referenced in O&M manual (Station 299+56).

View of marker visible on waterward shoulder.

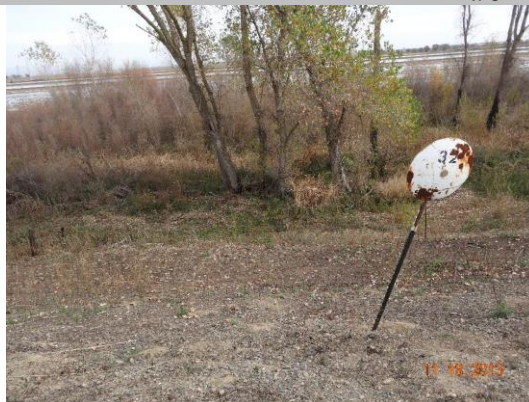
Photo 2 of 3 : UCIP\_SP\_2017\_24816\_44610.jpg

View of waterward slope.

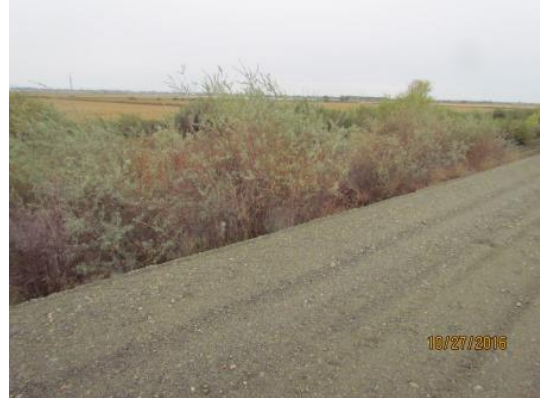
Photo 1 of 1 : SP\_2017\_RD0010\_163\_49\_20170316\_00019.jpg

LM Start	3.93	Rating **	M	Issue No.	49
LM End	3.93	Issue Type +	Ma	Location *	WS
Category	Earthen Levee			GPS Latitude/Longitude	
				Start	End
Item	Trim / Thin Trees			39.202570 °	39.202570 °
				-121.581681 °	-121.581681 °
DWR ID	DWR_RD0010_01_s_2016_49				
Comment Code					
T2 : Thin trees to allow visibility of the ground and room to flood fight.					
Inspector Comment					
Remove small willow trees from levee slope. Fall 2016.

View of small starter willow trees on the landside looking upstream. Fall 2016.

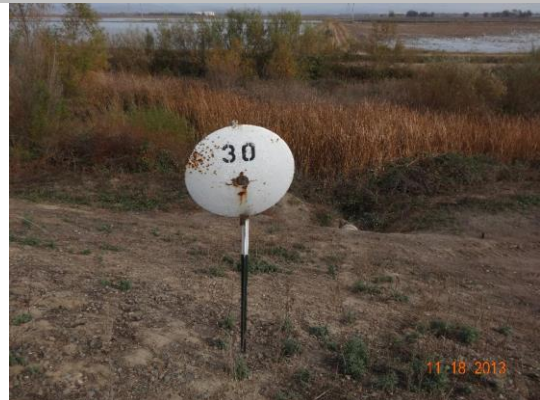
Photo 1 of 3 : UCIP\_SP\_2017\_27747\_51441.jpg

Comment Code					
Inspector Comment					
FS_ID:27747					
DS_ID:21274					
EP_NO: N/A					
Repair Type: Non-Urgent					
Crossing Status: Indicator Found					
UCIP Comments: sign marker on WS 30; Unable to confirm landward side. This crossing is referenced in the USACE Periodic Inspection as item USACE_CESPK_HON1_2013_p_0232.					
FIELD_STRUCT_DESC: 24-inch CM drainpipe through the levee, 18.0 feet below the crown. CM cutoff wall around pipe at center of levee.					
Flap gate and splash apron (6x6 foot) on the waterward end. (USACE-1953). This entry matches the Drainage or Irrigation Structure referenced in O&M manual (Station 339+55.10).					
FS Date: 4/29/2013

View of waterward side--marker indicating crossing located on waterward shoulder.

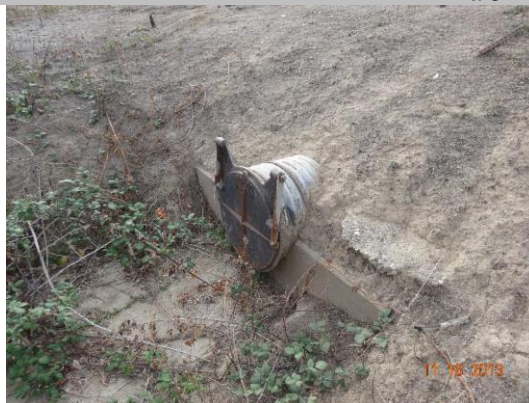
Photo 2 of 3 : UCIP\_SP\_2017\_27747\_51445.jpg

Comment Code						
Inspector Comment						
FS_ID:27747						
DS_ID:21274						
EP_NO: N/A						
Repair Type: Non-Urgent						
Crossing Status: Indicator Found						
UCIP Comments: sign marker on WS 30; Unable to confirm landward side. This crossing is referenced in the USACE Periodic Inspection as item USACE_CESPK_HON1_2013_p_0232.						
FIELD_STRUCT_DESC: 24-inch CM drainpipe through the levee, 18.0 feet below the crown. CM cutoff wall around pipe at center of levee.						
Flap gate and splash apron (6x6 foot) on the waterward end. (USACE-1953). This entry matches the Drainage or Irrigation Structure referenced in O&M manual (Station 339+55.10).						
FS Date: 4/29/2013

View of pipe, flap gate, and headwall located on waterward toe.

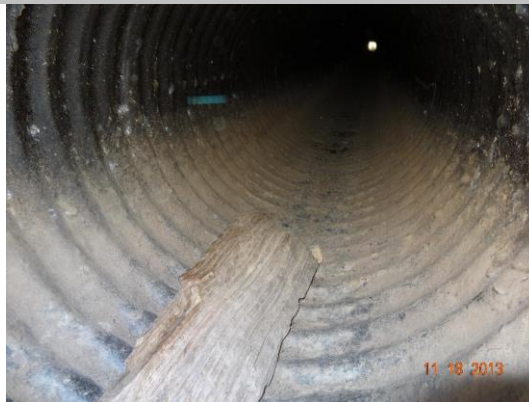
Photo 3 of 3 : UCIP\_SP\_2017\_27747\_51443.jpg

Internal view of pipe wall using camera with flash.

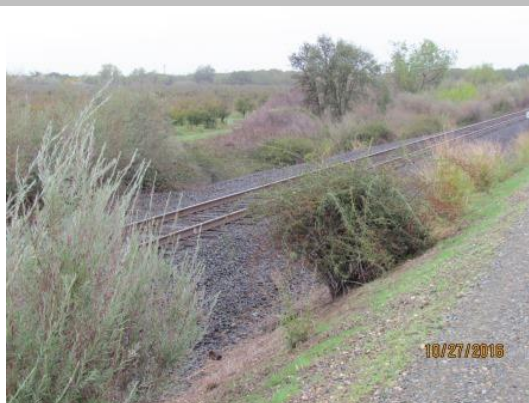
Photo 1 of 1 : SP\_2017\_RD0010\_163\_45\_20170316\_00014.jpg

LM Start	4.84	Rating **	M	Issue No.	45	
LM End	4.84	Issue Type +	Ma	Location *	LS	
Category	Earthen Levee			GPS Latitude/Longitude		
				Start		End
Item	Vegetation			39.215748 °		39.215748 °
				-121.580032 °		-121.580032 °
DWR ID	DWR_RD0010_01_s_2016_45					
Comment Code						
V2 : Remove the wild growth other than native grasses from the levee slopes.						
Inspector Comment						
Wild Rosebush on landside slope needs to be removed.

View of wild rosebush on the landside levee slope looking upstream. Fall 2016.

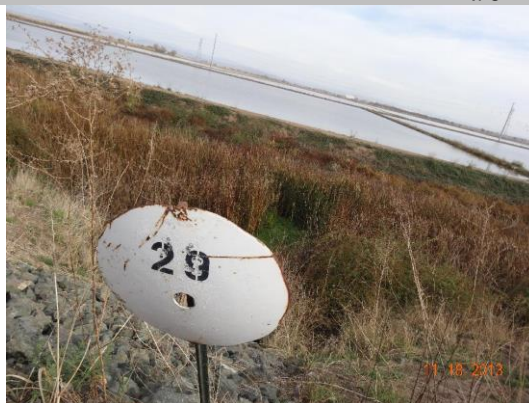
Photo 1 of 3 : UCIP\_SP\_2017\_49988\_44811.jpg

FS\_ID:49988  
DS\_ID:21275  
EP\_NO: N/A  
Repair Type: Non-Urgent  
Crossing Status: Found  
UCIP Comments: 7/01/2016 WS slope appears to be stable; UCIP issue has been downgraded from Urgent to Non-Urgent due to what appears to be a stable slope--no other issues were observed during the site visit. The reason for the Non-Urgent classification is due to the limited documentation available to support extent of repair--need to obtain repair records to determine extent of repair and to determine if pipe was replaced through the levee. (DWR UCIP - omagana)4/29/2013 limited access; steep slopes, and dense vegetation; New riprap has been placed along pipe alignment need to contact owner to determine work authorization. Also need to find out if the design for riprap was due to slope failure at this location. This crossing is referenced in the USACE Periodic Inspection as item USACE\_CESPK\_HON1\_2013\_p\_0246. (DWR UCIP - omagana) FIELD\_STRUCT\_DESC: 36-inch corrugated metal drainage pipe through the levee, 20 feet below the crown. Two CM cutoff walls around pipe are located on both shoulders. Flap gate is located on the waterside (WS) end. Concrete headwall is located on the WS toe. Grouted cobble headwall is located on the landside (LS) toe. Concrete saddle and apron are located on the WS. [Additional Reference(s): DWR Levee Log, 2005. USACE Sacramento O&M Manual Unit No. 151, May 1953, Station 381+76.24].

Marker for pipe crossing visible on WS shoulder.

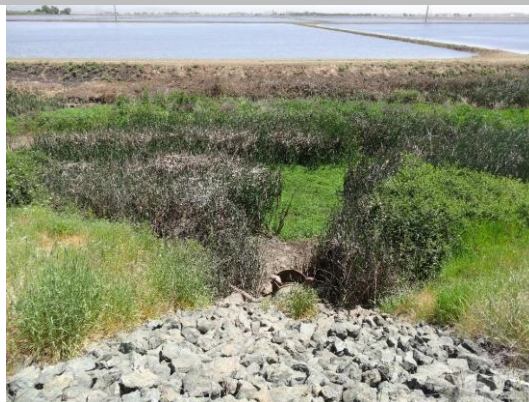
Photo 2 of 3 : UCIP\_SP\_2017\_49988\_44809.jpg

View of WS during April.

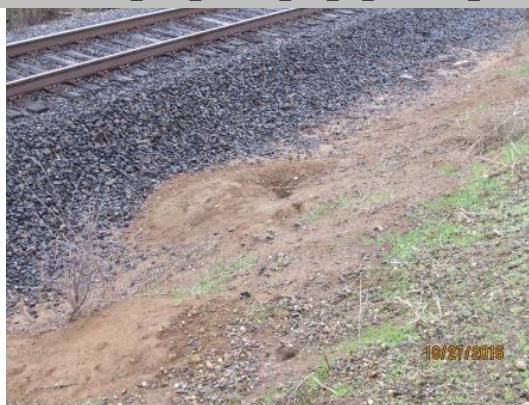
Photo 1 of 1 : SP\_2017\_RD0010\_163\_42\_20170316\_00013.jpg

LM Start	5.04	Rating **	M	Issue No.	42
LM End	5.04	Issue Type +	Ma	Location *	LS
Category	Earthen Levee			GPS Latitude/Longitude	
				Start	End
Item	Animal Control			39.218564 °	39.218564 °
				-121.579682 °	-121.579682 °
DWR ID	DWR_RD0010_01_s_2016_42				
Comment Code					
A3 : No rodents visible, but rodent burrows visible; need to backfill and compact or grout burrows.					
Inspector Comment					
Squirrel hole still are visible but no sign of activity, Fall 2016.

View of squirrel hole on landside toe, no sign of activity. Fall 2016.

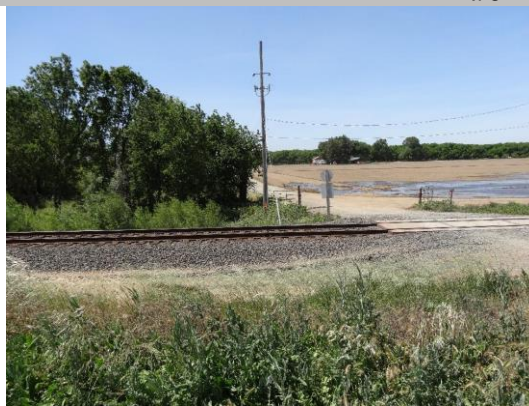
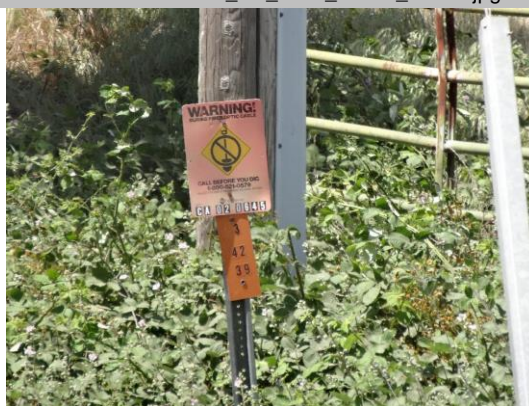
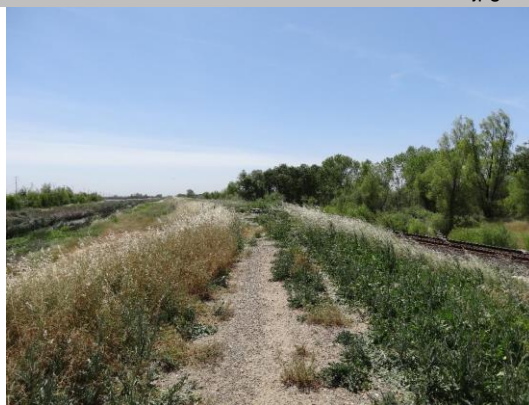
LM Start	6.14	Rating **	M	Issue No.	88
LM End	6.14	Issue Type +	En	Location *	LS
Category	Supplemental			GPS Latitude/Longitude	
				Start	End
Item	DWR UCIP Field Study			39.234389 °	39.234389 °
				-121.577620 °	-121.577620 °
DWR ID					
Comment Code					
Inspector Comment					
FS_ID:27531 DS_ID:21277 EP_NO: 6127 Repair Type: Non-Urgent Crossing Status: Indicator Found UCIP Comments: Recommend removing vegetation along pipe alignment to conduct proper inspection of structure and appurtances. FIELD_STRUCT_DESC: Two 1-inch aluminum conduits through the levee, 3.0 feet below the crown. Cutoff wall around conduits at center of levee. (Permit No. 6217-1968) FS Date: 4/29/2013

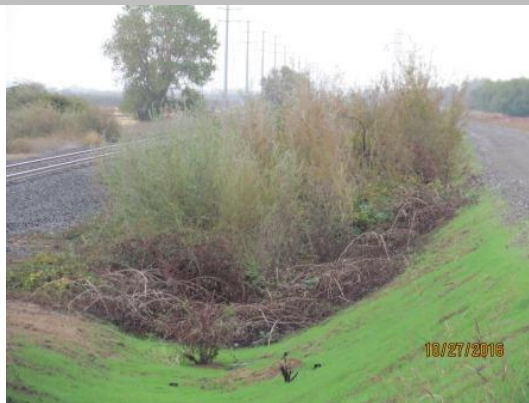
Photo 2 of 2 : SP\_2017\_RD0010\_163\_36\_20170316\_00010.jpg

View looking upstream landside of willows and wild rosebushes that are blocking visibility at the toe. Fall 2016.

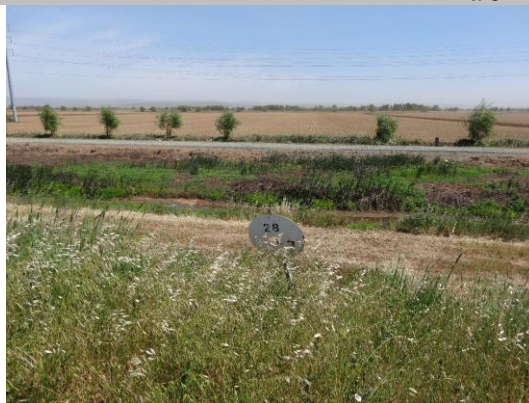
Photo 1 of 3 : UCIP\_SP\_2017\_24438\_43503.jpg

Comment Code					
Inspector Comment					
FS_ID:24438 DS_ID:21278 EP_NO: N/A Repair Type: Non-Urgent Crossing Status: Found UCIP Comments: Dense vegetation limits the inspector's visibility to identify signs of pipe failure (leaks) along the slope. Recommend removing vegetation along pipe alignment to conduct proper inspection of structure and appurtances. This crossing is referenced in the USACE Periodic Inspection as item USACE_CESPK_HON1_2013_p_0290. FIELD_STRUCT_DESC: 30-inch CM pipe through the levee, 12.5 feet below the crown. Two CM cutoff walls around pipe at both shoulders. Flap gate on the waterward end. Concrete headwall, saddle and apron on the waterward end. (USACE-1953). This entry matches the Drainage or Irrigation Structure referenced in O&M manual (Station 455+00). FS Date: 4/29/2013

Marker visible on waterward shoulder.

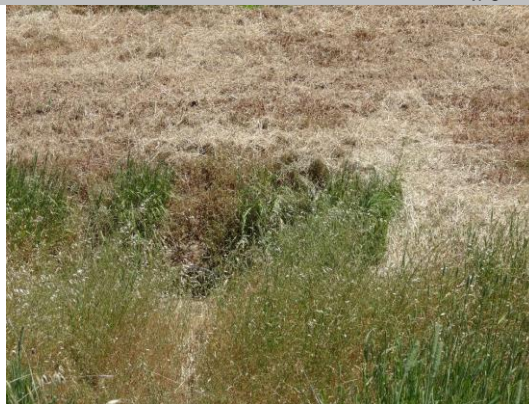
Photo 2 of 3 : UCIP\_SP\_2017\_24438\_43502.jpg

View of waterward toe where pipe daylights.

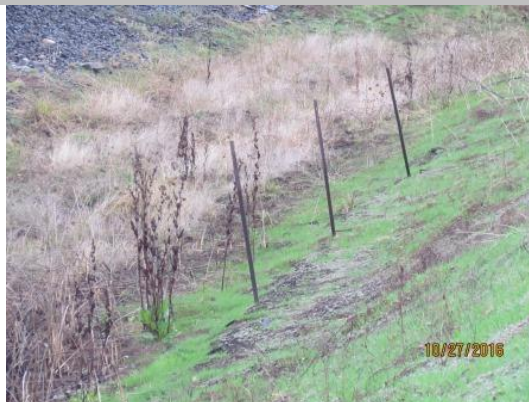
Photo 1 of 1 : SP\_2017\_RD0010\_163\_33\_20170316\_00007.jpg

LM Start	6.48	Rating **	M	Issue No.	33
LM End	7.13	Issue Type +	En	Location *	LS
Category	Earthen Levee			GPS Latitude/Longitude	
				Start	End
Item	Encroachments			39.239303 °	39.248725 °
				-121.576970 °	-121.575824 °
DWR ID	DWR_RD0010_01_s_2016_33				
Comment Code					
FE : Fence					
Inspector Comment					
Fence t-post at levee toe should be removed. Fall 2016.

View of fence post that run along the landside levee toe, looking upstream. Fall 2016.

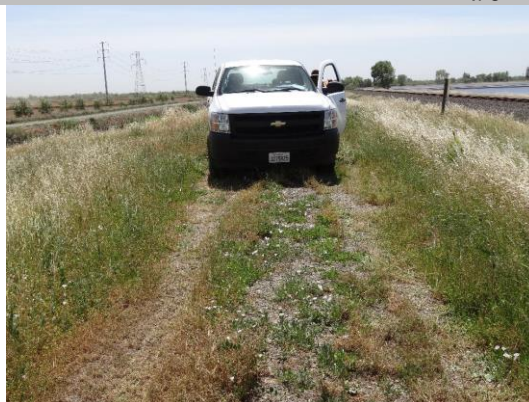
Photo 2 of 3 : UCIP\_SP\_2017\_27532\_51128.jpg

Comment Code					
Inspector Comment					
FS_ID:27532					
DS_ID:21279					
EP_NO: N/A					
Repair Type: Non-Urgent					
Crossing Status: Found					
UCIP Comments: Need to clear sediment near gate. Need to coordinate with owner to determine status of crossing. If crossing is no longer in use owner will need to contact the CVFPB to comply with Title 23. This crossing is referenced in the USACE Periodic Inspection as item USACE_CESPK_HON1_2013_p_0291-294.					
FIELD_STRUCT_DESC: 16-inch-steel pipe through the levee, 10.3 feet below the crown. Cutoff wall around pipe at center of levee. Slide gate on the waterward end. Pipe exposed across irrigation canal on landward side. (USACE-1953). This entry matches the Drainage or Irrigation Structure referenced in O&M manual (Station 473+58).					
FS Date: 4/29/2013

View of levee looking downstream.

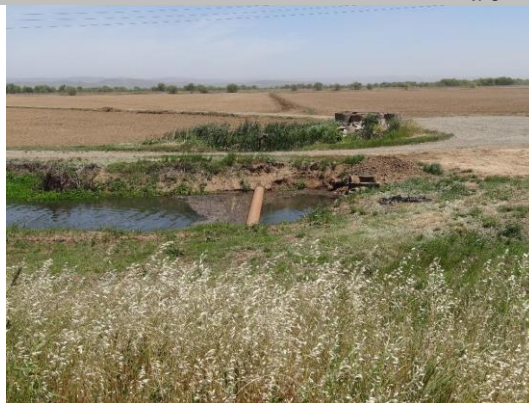
Photo 3 of 3 : UCIP\_SP\_2017\_27532\_51130.jpg

Comment Code						
Inspector Comment						
FS_ID:27532						
DS_ID:21279						
EP_NO: N/A						
Repair Type: Non-Urgent						
Crossing Status: Found						
UCIP Comments: Need to clear sediment near gate. Need to coordinate with owner to determine status of crossing. If crossing is no longer in use owner will need to contact the CVFPB to comply with Title 23. This crossing is referenced in the USACE Periodic Inspection as item USACE_CESPK_HON1_2013_p_0291-294.						
FIELD_STRUCT_DESC: 16-inch-steel pipe through the levee, 10.3 feet below the crown. Cutoff wall around pipe at center of levee. Slide gate on the waterward end. Pipe exposed across irrigation canal on landward side. (USACE-1953). This entry matches the Drainage or Irrigation Structure referenced in O&M manual (Station 473+58).						
FS Date: 4/29/2013

View of waterward side--pipe goes through Simmerly Slough.

LM Start	6.82	Rating **	M	Issue No.	27
LM End	6.82	Issue Type +	En	Location *	CR
Category	Earthen Levee			GPS Latitude/Longitude	
				Start	End
Item	Encroachments			39.244203 °	39.244203 °
				-121.576246 °	-121.576246 °
DWR ID	DWR_RD0010_01_f_2015_27				
Comment Code					
PI : Pipe					
Inspector Comment					
Spring 2016; the pipe bored through levee caused depression in crown 11' wide by 6" deep. Land owner is Charley Mathews. There is no longer a depression after the new aggregate base was placed in the Fall 2016. A notice of violation has been sent to the land owner by the Board in the fall of 2016.

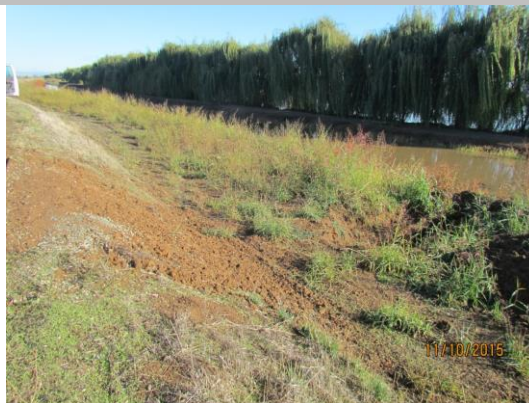
Photo 2 of 4 : SP\_2017\_RD0010\_163\_27\_20170316\_00002.jpg

LM Start	6.82	Rating **	M	Issue No.	27 (cont)
LM End	6.82	Issue Type +	En	Location *	CR
Category	Earthen Levee			GPS Latitude/Longitude	
				Start	End
Item	Encroachments			39.244203 °	39.244203 °
				-121.576246 °	-121.576246 °
DWR ID	DWR_RD0010_01_f_2015_27				
Comment Code					
PI : Pipe					
Inspector Comment					
Spring 2016; the pipe bored through levee caused depression in crown 11' wide by 6" deep. Land owner is Charley Mathews. There is no longer a depression after the new aggregate base was placed in the Fall 2016. A notice of violation has been sent to the land owner by the Board in the fall of 2016.

View of the trench on the waterward side of the levee looking upstream. Works seem to have been done on the levee slope as well. Fall 2015.

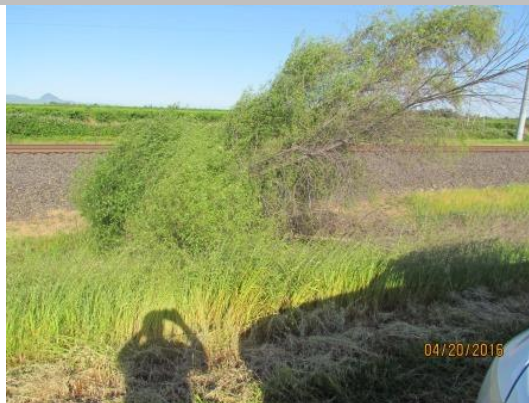
Photo 1 of 2 : SP\_2017\_RD0010\_163\_32\_20170316\_00005.jpg

LM Start	7.27	Rating **	M	Issue No.	32
LM End	7.27	Issue Type +	Ma	Location *	LS
Category	Earthen Levee			GPS Latitude/Longitude	
				Start	End
Item	Trim / Thin Trees			39.250651 °	39.250651 °
				-121.575579 °	-121.575579 °
DWR ID	DWR_RD0010_01_s_2016_32				
Comment Code					
T1 : Trim trees to at least five feet above ground level.					
Inspector Comment					
Small trees 4" in diameter at chest height should be removed before they get to big.

View of a tree that needs to be removed. Small trees 4" in diameter at chest height should be removed before they get to big. View of landside. Spring 2016.

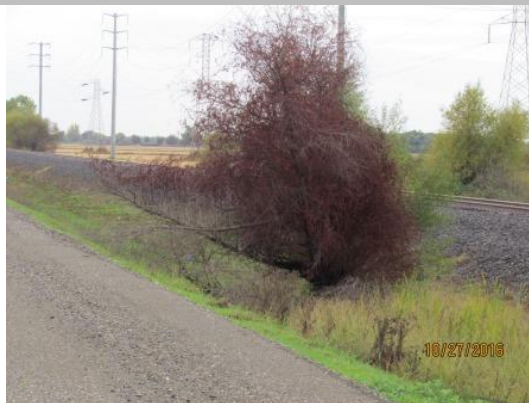
Photo 2 of 2 : SP\_2017\_RD0010\_163\_32\_20170316\_00006.jpg

View of a tree that needs to be removed on the landside, looking downstream. Fall 2016.

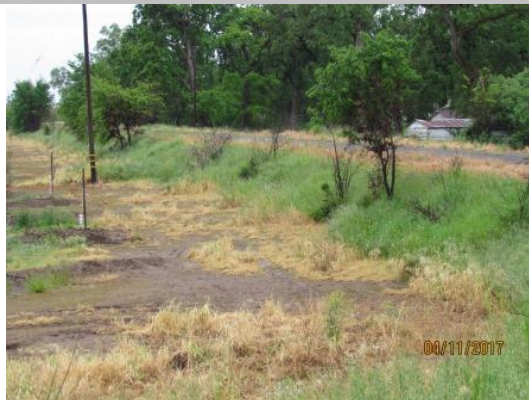
Photo 1 of 1 : SP\_2017\_RD0010\_164\_41\_20170414\_00109.jpg

LM Start	0.01	Rating **	M	Issue No.	41
LM End	10.81	Issue Type +	Ma	Location *	LS
Category	Earthen Levee			GPS Latitude/Longitude	
				Start	End
Item	Vegetation			39.163798 °	39.302253 °
				-121.610009 °	-121.617922 °
DWR ID	DWR_RD0010_02_s_2017_41				
Comment Code					
V1 : Control annual grass and weeds on the levee slopes and easements.					
Inspector Comment					
The annual grasses on the slope needs to be maintained, the crown and shoulders have been sprayed, Spring 2017.

View looking downstream of annual vegetation. The slope needs to be maintained, the crown and shoulders have been sprayed, Spring 2017.

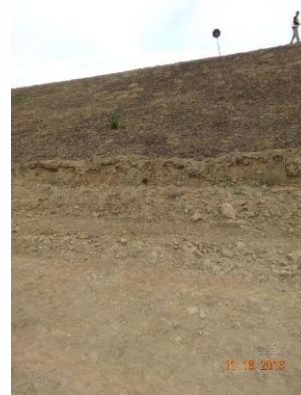
Photo 2 of 3 : UCIP\_SP\_2017\_27533\_51137.jpg

Comment Code					
Inspector Comment					
FS_ID:27533 DS_ID:21280 EP_NO: N/A Repair Type: Non-Urgent Crossing Status: Found UCIP Comments: Recommend removing vegetation and debris along pipe alignment (debris blocking gate on waterward side and vegetation blocking access to screw gate on landward side). Need to coordinate with owner to determine status of crossing. If crossing is no longer in use owner will need to contact the CVFPB to comply with Title 23. This crossing is referenced in the USACE Periodic Inspection as item USACE_CESPK_HON2_2013_p_0027. FIELD_STRUCT_DESC: 24-inch CM pipe through the levee, 25.6 feet below the crown. Two CM cutoff walls around pipe at both shoulders. Flap gate on the waterward end. Concrete headwall, saddle and apron on the waterward end. (USACE-1953). This entry matches the Drainage or Irrigation Structure referenced in O&M manual (Station 106+00). FS Date: 4/30/2013

View of waterward slope.

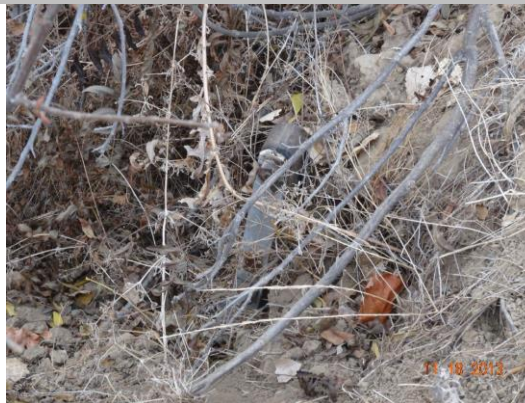
Photo 3 of 3 : UCIP\_SP\_2017\_27533\_51138.jpg

Buried flap gate on waterward side.

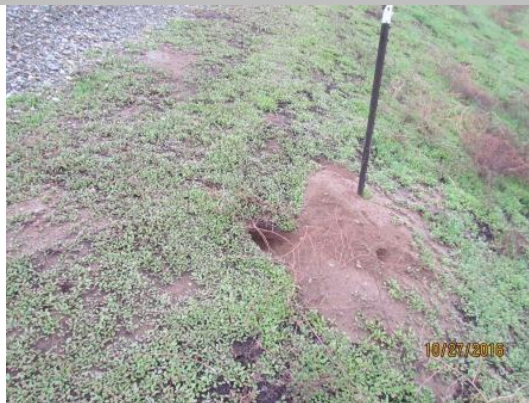
Photo 1 of 1 : SP\_2017\_RD0010\_164\_28\_20170316\_00007.jpg

LM Start	0.38	Rating **	M	Issue No.	28
LM End	0.38	Issue Type +	Ma	Location *	WS
Category	Earthen Levee			GPS Latitude/Longitude	
				Start	End
Item	Animal Control			39.169231 °	39.169231 °
				-121.610711 °	-121.610711 °
DWR ID	DWR_RD0010_02_f_2015_28				
Comment Code					
A3 : No rodents visible, but rodent burrows visible; need to backfill and compact or grout burrows.					
Inspector Comment					
No rodent activity but squirrel hole needs to be backfilled. Spring 2017.

View of squirrel hole on the waterside looking downstream. Fall 2016

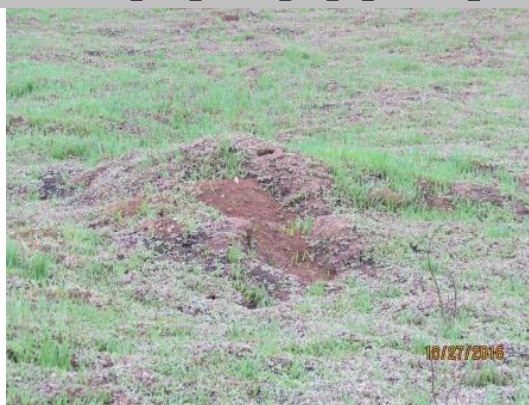
Photo 1 of 1 : SP\_2017\_RD0010\_164\_29\_20170316\_00008.jpg

LM Start	0.94	Rating **	M	Issue No.	29
LM End	0.94	Issue Type +	Ma	Location *	WS
Category	Earthen Levee			GPS Latitude/Longitude	
				Start	End
Item	Animal Control			39.177289 °	39.177289 °
				-121.609860 °	-121.609860 °
DWR ID	DWR_RD0010_02_f_2015_29				
Comment Code					
A1 : Exterminate rodents and backfill and compact or grout burrows.					
Inspector Comment					
No rodent activity but squirrel hole needs to be backfilled. Spring 2017.

View of rodent hole that has more than 2 cubic feet of material on the waterside.

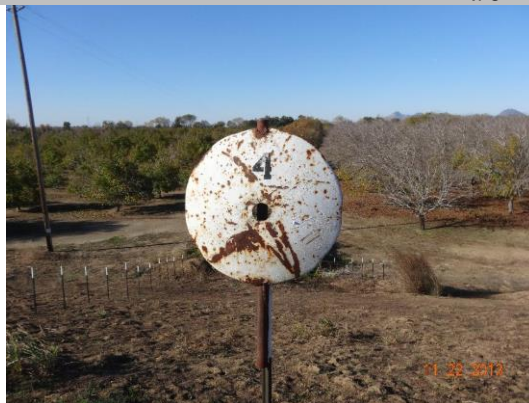
Photo 1 of 3 : UCIP\_SP\_2017\_24821\_44640.jpg

FS\_ID:24821  
DS\_ID:21281  
EP\_NO: N/A  
Repair Type: Non-Urgent  
Crossing Status: Found  
UCIP Comments: Screw gate on landward side is blocked by sediment. Recommend removing sediment in front of gate. This crossing is referenced in the USACE Periodic Inspection as item USACE\_CESPK\_HON2\_2013\_p\_0082.  
FIELD\_STRUCT\_DESC: 24-inch CM pipe through the levee, 26.0 feet below the crown. Two CM cutoff walls around pipe at both shoulders. Flap gate on the waterward end. Slide gate on landward end. Concrete headwall, saddle and apron on the waterward end. (USACE-1953). This entry matches the Drainage or Irrigation Structure referenced in O&M manual (Station 149+88).  
FS Date: 4/30/2013

Marker visible on waterward side--No. 4.

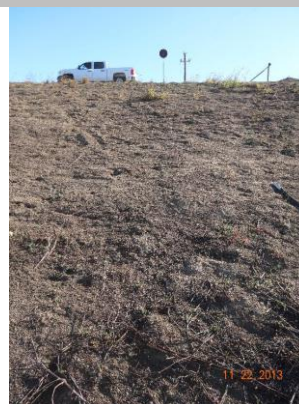
Photo 2 of 3 : UCIP\_SP\_2017\_24821\_44639.jpg

View of waterward slope side.

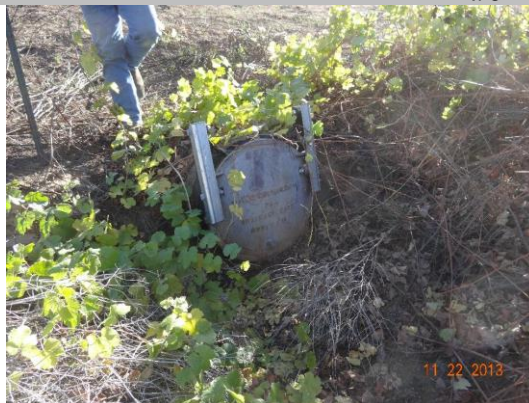
Photo 3 of 3 : UCIP\_SP\_2017\_24821\_44638.jpg

Comment Code						
Inspector Comment						
FS_ID:24821						
DS_ID:21281						
EP_NO: N/A						
Repair Type: Non-Urgent						
Crossing Status: Found						
UCIP Comments: Screw gate on landward side is blocked by sediment.						
Recommend removing sediment in front of gate. This crossing is						
referenced in the USACE Periodic Inspection as item						
USACE_CESPK_HON2_2013_p_0082.						
FIELD_STRUCT_DESC: 24-inch CM pipe through the levee, 26.0 feet						
below the crown. Two CM cutoff walls around pipe at both shoulders.						
Flap gate on the waterward end. Slide gate on landward end. Concrete						
headwall, saddle and apron on the waterward end. (USACE-1953). This						
entry matches the Drainage or Irrigation Structure referenced in O&M						
manual (Station 149+88).						
FS Date: 4/30/2013

View of flap gate located on waterward side.

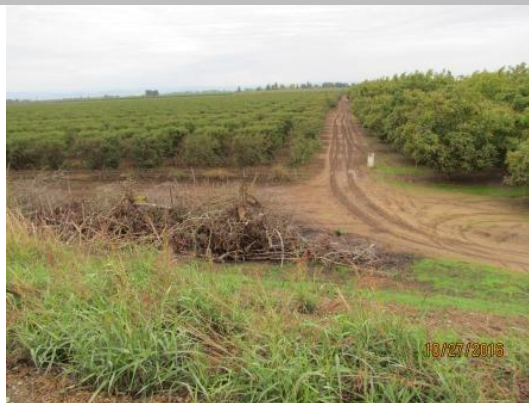
Photo 1 of 1 : SP\_2017\_RD0010\_164\_39\_20170316\_00017.jpg

LM Start	1.80	Rating **	M	Issue No.	39
LM End	1.80	Issue Type +	En	Location *	LS
Category	Earthen Levee			GPS Latitude/Longitude	
				Start	End
Item	Encroachments			39.189467 °	39.189467 °
				-121.607991 °	-121.607991 °
DWR ID	DWR_RD0010_02_s_2016_39				
Comment Code					
PR : Prunings					
Inspector Comment					
Remove pruning's from toe of slope.

View of pruning's at landside levee toe.

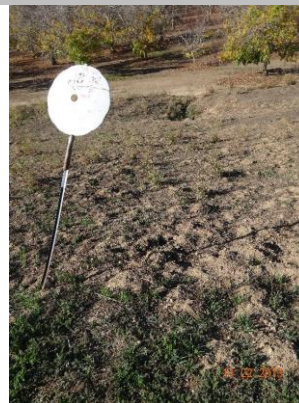
Photo 2 of 3 : UCIP\_SP\_2017\_27773\_51460.jpg

LM Start	3.10	Rating **	M	Issue No.	82 (cont)	
LM End	3.10	Issue Type +	En	Location *	LS	
Category	Supplemental			GPS Latitude/Longitude		
				Start	End	
Item	DWR UCIP Field Study			39.208193 °	39.208193 °	
				-121.609909 °	-121.609909 °	
DWR ID						
Comment Code						
Inspector Comment						
FS_ID:27773 DS_ID:21283 EP_NO: N/A Repair Type: Non-Urgent Crossing Status: Found UCIP Comments: High rodent activity along pipe alignment--animal control would be beneficial. This crossing is referenced in the USACE Periodic Inspection as item USACE_CESPK_HON2_2013_p_0150. FIELD_STRUCT_DESC: 30-inch CM drainpipe through the levee, 22.5 feet below the crown. Flap gate on the waterward end. Metal marker on waterward shoulder. FS Date: 4/30/2013

View of waterward side--burrow activity present on slope.

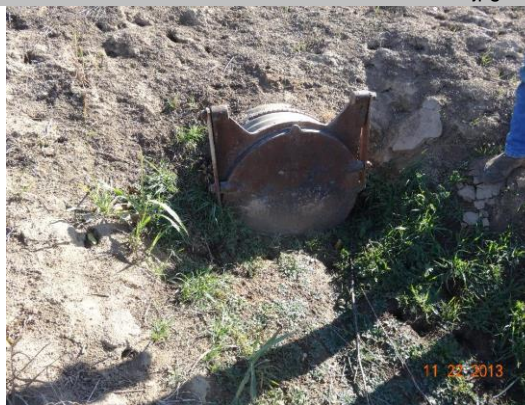
Photo 3 of 3 : UCIP\_SP\_2017\_27773\_51464.jpg

View of gate on waterward side.

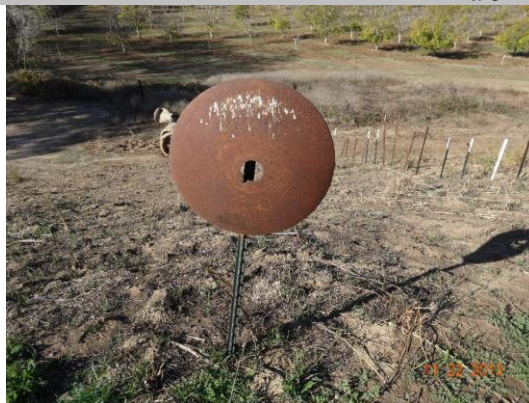
Photo 1 of 3 : UCIP\_SP\_2017\_24824\_44658.jpg

Comment Code					
Inspector Comment					
FS_ID:24824					
DS_ID:21284					
EP_NO: N/A					
Repair Type: Non-Urgent					
Crossing Status: Found					
UCIP Comments: Remove concrete piece preventing complete closure of screw gate on landward side. This crossing is referenced in the USACE Periodic Inspection as item					
USACE_CESPK_HON2_2013_p_0152.					
FIELD_STRUCT_DESC: 36-inch CM drainpipe through the levee, 24.0 feet below the crown. Two CM cutoff walls around pipe at both shoulders. Flap gate on the waterward end. Slide gate on the landward end. Concrete headwalls at both ends. (USACE-1953). This entry matches the Drainage or Irrigation Structure referenced in O&M manual (Station 259+76).					
FS Date: 4/30/2013

Marker visible on waterward side.

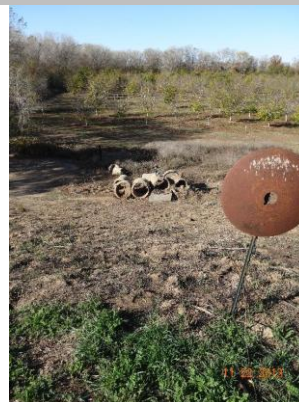
Photo 2 of 3 : UCIP\_SP\_2017\_24824\_44657.jpg

Overview of waterward slope--barrier placed at toe to discourage damage to crossing.

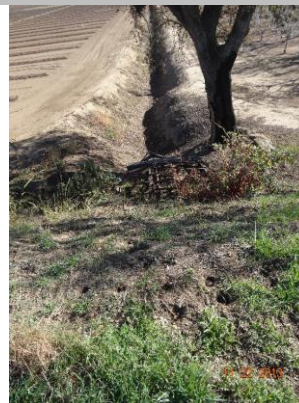
Photo 3 of 3 : UCIP\_SP\_2017\_24824\_44656.jpg

Comment Code						
Inspector Comment						
FS_ID:24824						
DS_ID:21284						
EP_NO: N/A						
Repair Type: Non-Urgent						
Crossing Status: Found						
UCIP Comments: Remove concrete piece preventing complete closure						
of screw gate on landward side. This crossing is referenced in the						
USACE Periodic Inspection as item						
USACE_CESPK_HON2_2013_p_0152.						
FIELD_STRUCT_DESC: 36-inch CM drainpipe through the levee, 24.0						
feet below the crown. Two CM cutoff walls around pipe at both						
shoulders. Flap gate on the waterward end. Slide gate on the landward						
end. Concrete headwalls at both ends. (USACE-1953). This entry						
matches the Drainage or Irrigation Structure referenced in O&M manual						
(Station 259+76).						
FS Date: 4/30/2013

View of landward side--barrier used to discourage damage to crossing near toe.
